Observations of New and Reprocessed Octopus 3[®] Tissue Stabilizers and Octopus4[®] Tissue Stabilizers

The objective of this study was to evaluate new sterile and reprocessed sterile Medtronic Octopus 3[®] and Octopus 4[®] Tissue Stabilizers (see attached product PDF files). A report dated May 24, 2004 contained information and data describing the differences observed between new sterile and reprocessed sterile Medtronic Octopus 3[®] and Octopus 4[®] Tissue Stabilizers. In that report a total of four devices were assessed, one new sterile Medtronic Octopus 3[®], one new sterile Medtronic Octopus 4[®], one reprocessed sterile Medtronic Octopus 3[®] (SterilMed) and one reprocessed sterile Medtronic Octopus 4[®] (Alliance). Subsequent to that report, eight additional reprocessed Medtronic Octopus 3[®] and Octopus 4[®] Tissue Stabilizers from the same two reprocessors were examined using similar microscopic and molecular techniques. On June 7, 2004 the additional reprocessed Medtronic Octopus 3[®] and Octopus 4[®] Tissue Stabilizers were received. Results of eight of those are contained in this study for a total of twelve devices, two new sterile devices and ten reprocessed devices.

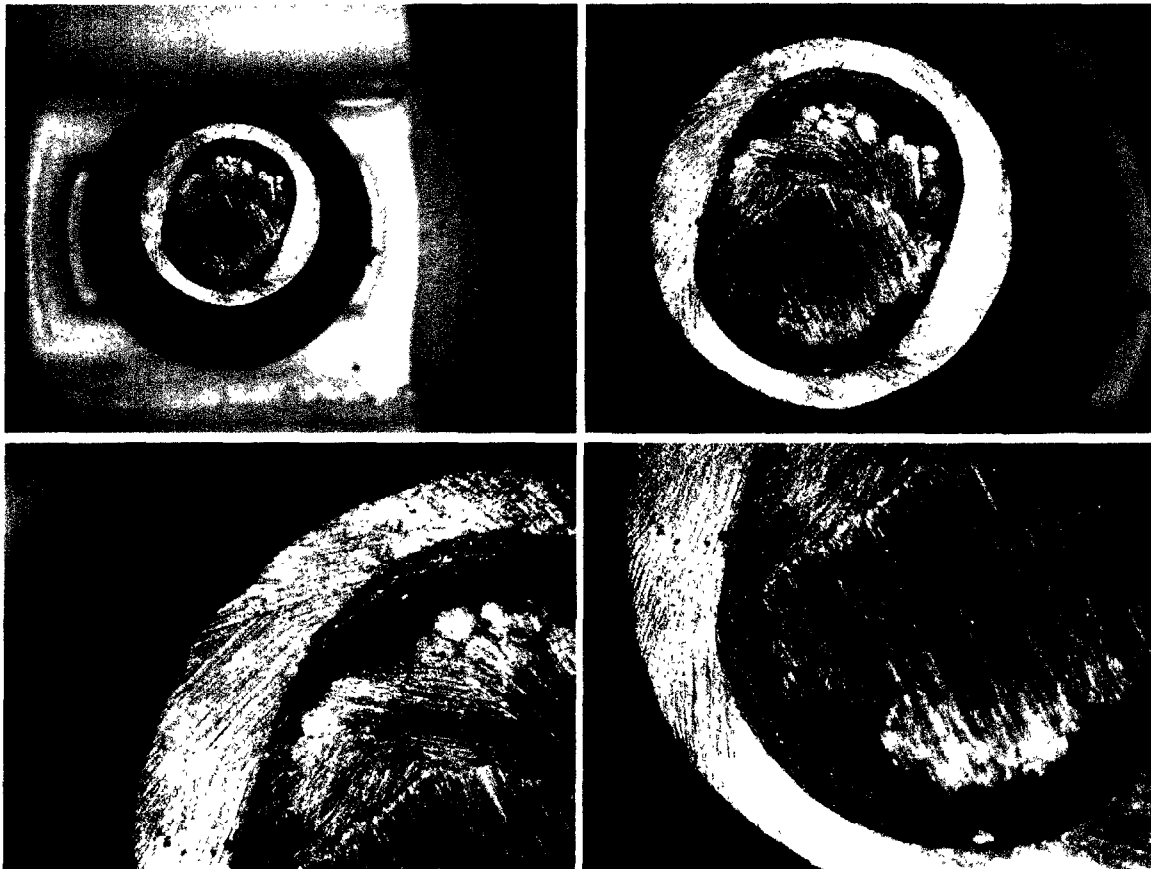
Corrosion and debris did not appear obvious in new sterile Octopus® devices. There is discoloration of the metal, presumably due to heat generated during a grinding/polishing process following the attachment of the integral cable to the ball joint. Example images are below:

Figure 8. Ball joint region from a new sterile Octopus 4® (MT-104-4). No corrosion or debris was observed.

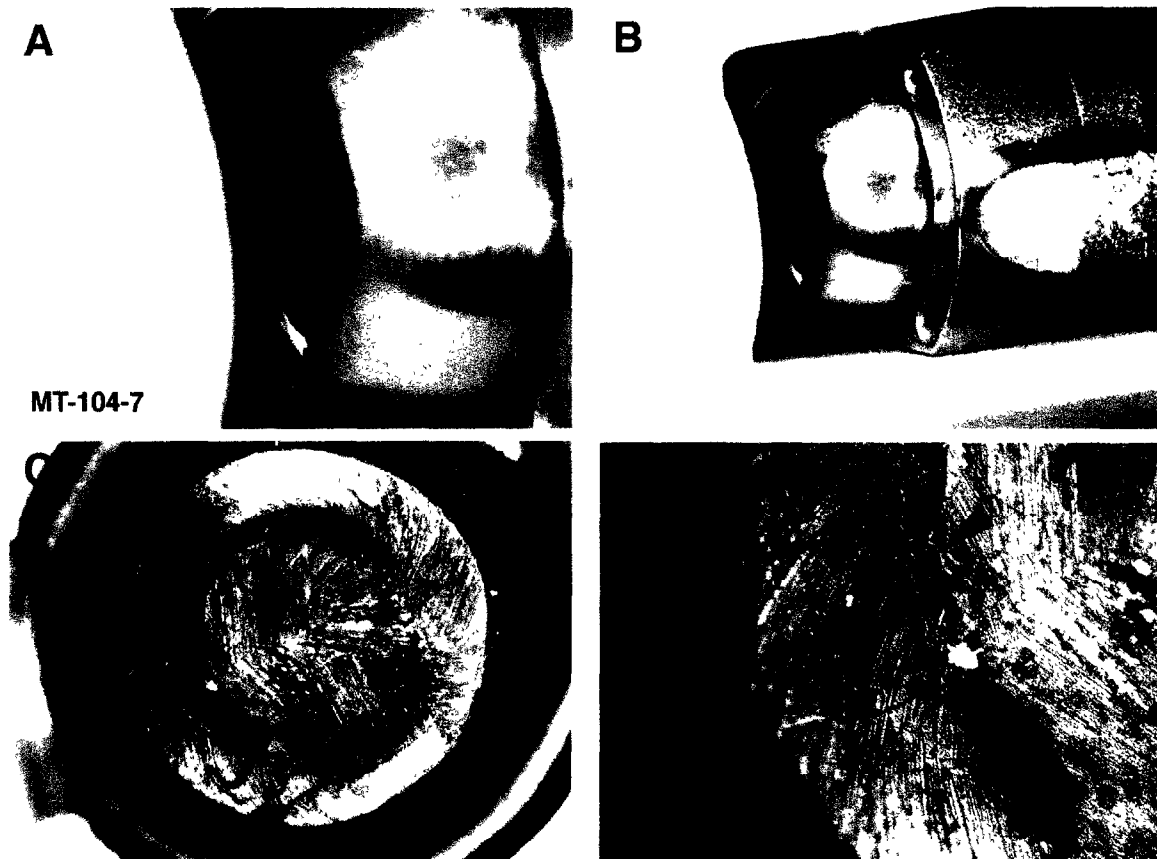
Reprocessed devices study IDs MT-104-3, 7, 8 and 9 (SterilMed) all had discoloration and significant corrosion in the cable attachment area of the ball joint region. All of the units had obvious bioburden and debris including hair or hair-like fibers (arrowheads) in the region of the ball joint. Example images from MT-104-7, 8 and 9 are below (arrowheads indicate hair, note extensive corrosion):

Figure 9. Stereomicroscopy images from **reprocessed device MT-104-7**. Arrowheads indicate hair, note extensive corrosion. Hair identified by cuticular scales and has been stained by the corrosion indicating its presence at the time of corrosion formation.

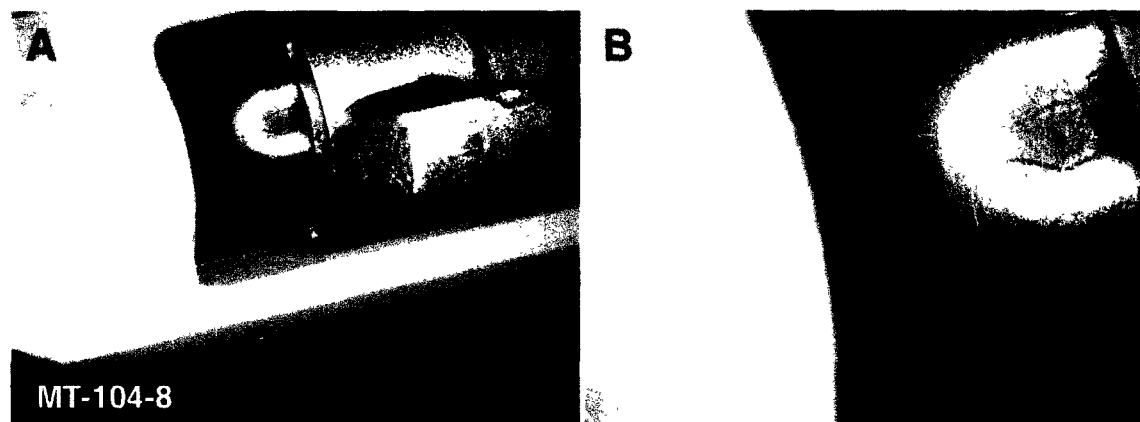
Figure 10. Stereomicroscopy images from **reprocessed device MT-104-8**. Arrowhead indicates hair or hair-like fiber.

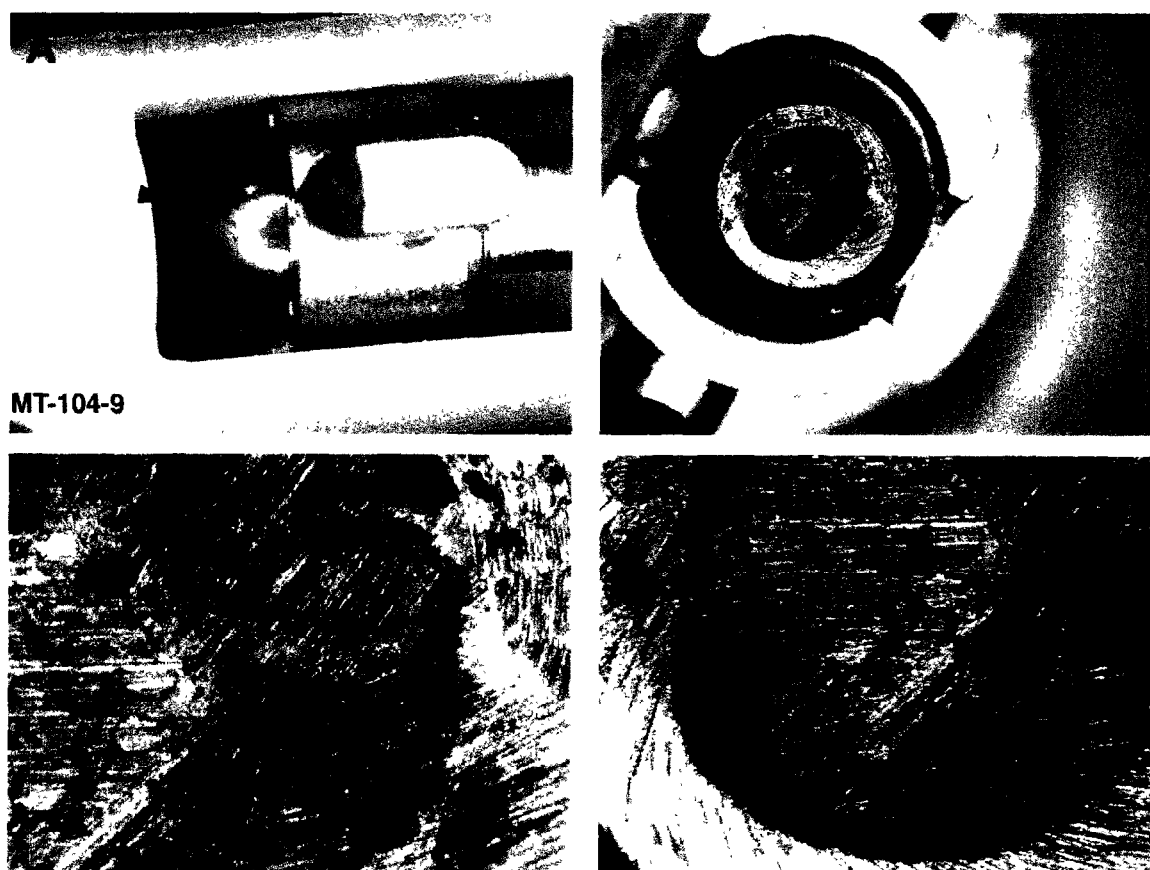
Figure 11. Stereomicroscopy images from **reprocessed device MT-104-9**. Arrowheads indicate hair, note extensive corrosion.

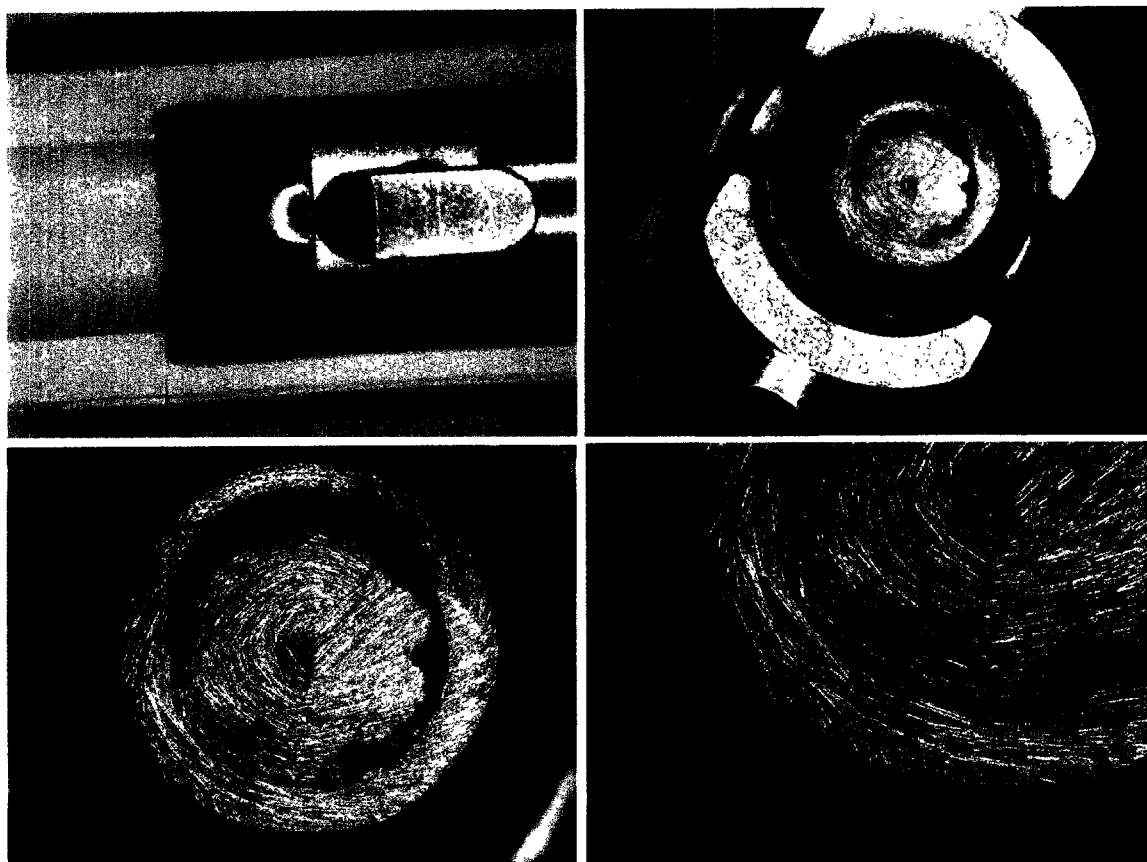
Significantly less corrosion and metal discoloration did appear on reprocessed Octopus[®] devices identified as MT-104-4, 5, 10, 11, 13 and 16 (Alliance) when compared to device IDs MT-104-3, 7, 8 and 9 (SterilMed). Example images from MT-104-5 and 10 are below:

Figure 12. Minor corrosion and metal discoloration (arrowhead) as compared to new on reprocessed Octopus4[®] (MT-104-5).

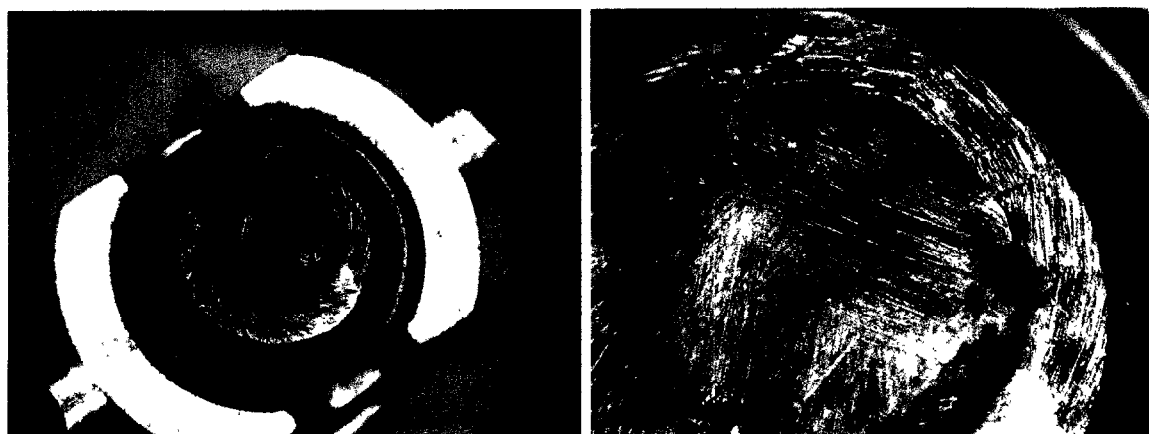
Figure 13. Minor corrosion and metal discoloration as compared to new on reprocessed Octopus4[®] (MT-104-10).

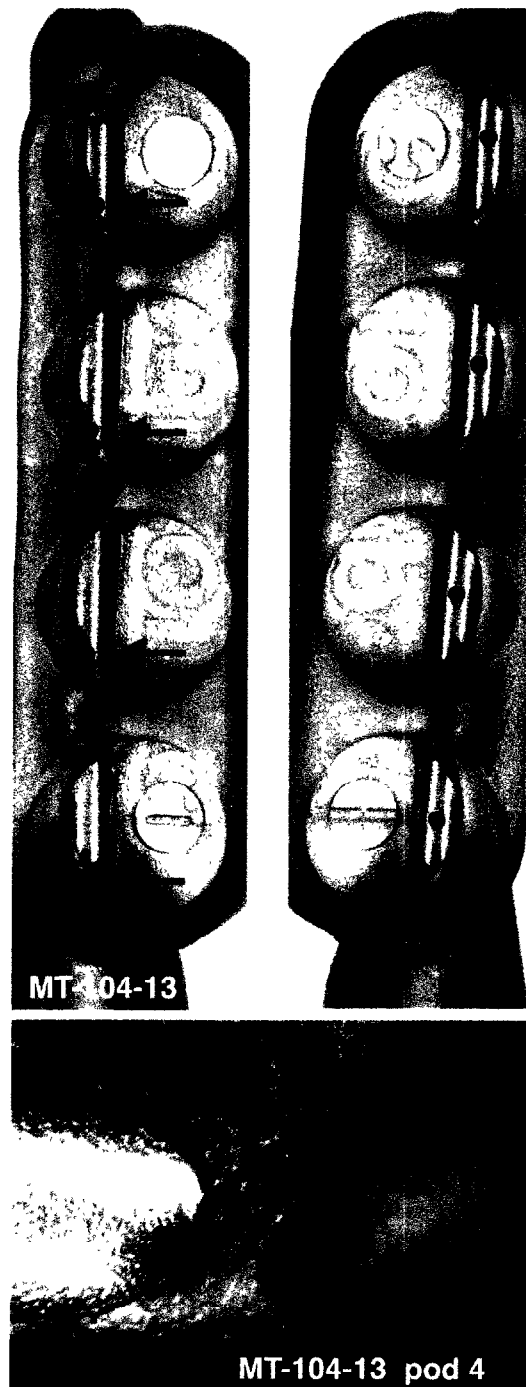
Figure 14. Reprocessed device MT-104-13 with blocked pod openings (arrows).

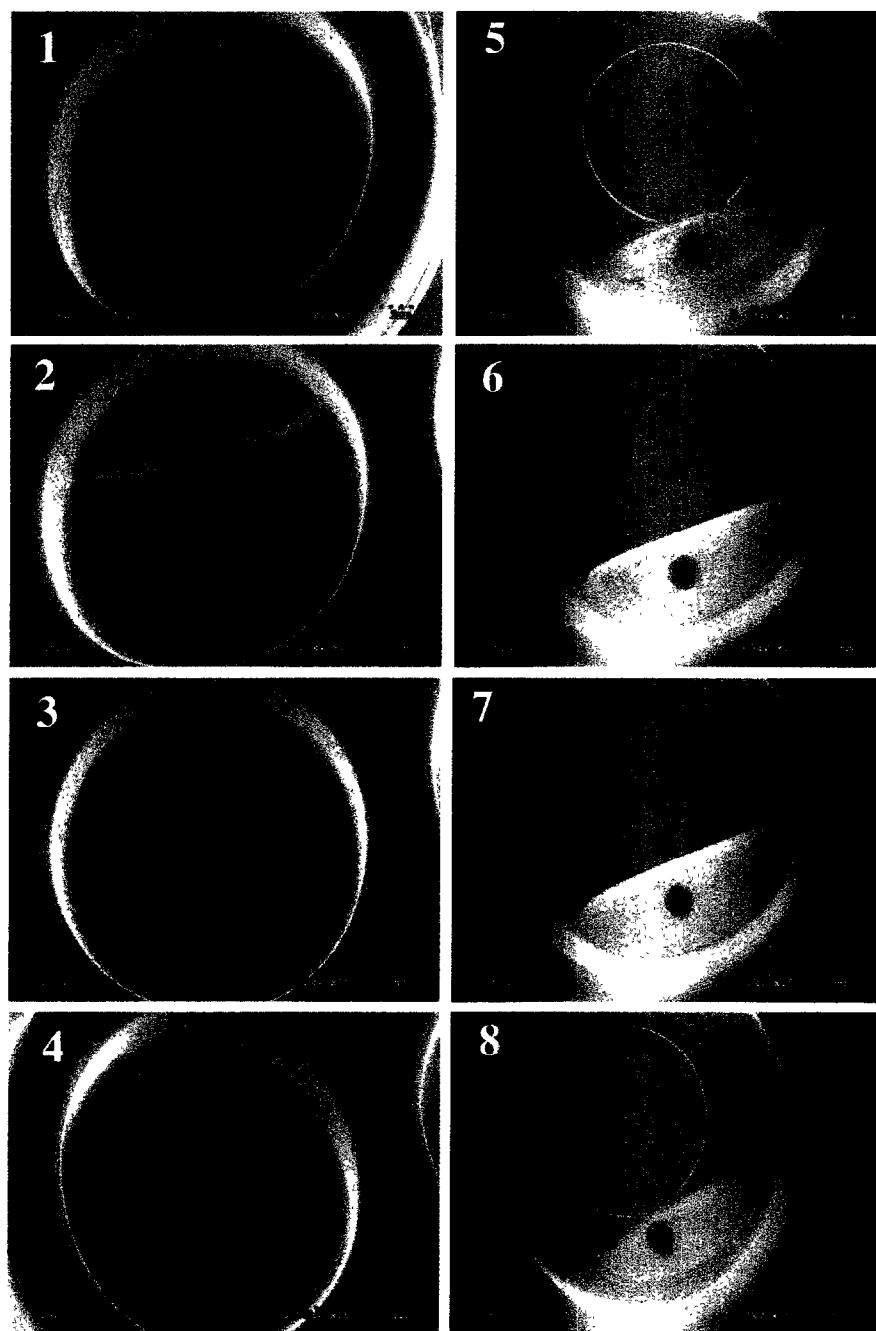
Figure 21. Series of images collected from Hitachi S3500N variable pressure scanning electron microscope in the areas of the pods on the **reprocessed Octopus 3[®] MT-104-3**. The images show irregularities on surface structure in the wells and tubing. There are irregularities and debris present in the orifices of the tubing. The numbers indicate the pod # (see Figure 5). Scale bar in each image.

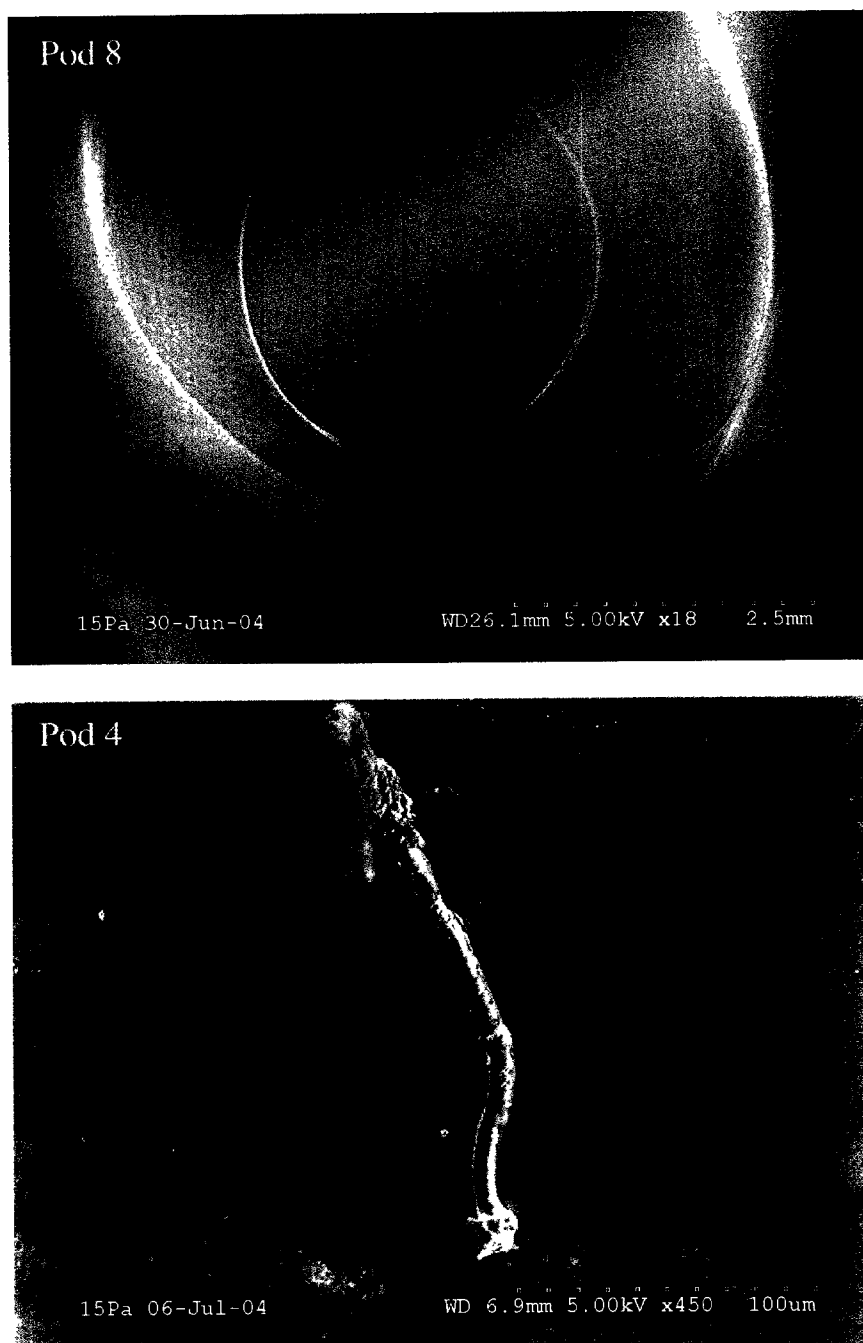
Figure 38. Series of images collected from Hitachi S3500N variable pressure scanning electron microscope of the **reprocessed Octopus 3[®] MT-104-8**. The images show several irregularities on surface structure of the tubing including a gap in the area of the pod surrounding the tubing. There is a fiber and irregularities present in the pod of the tubing. Scale bar in each image.

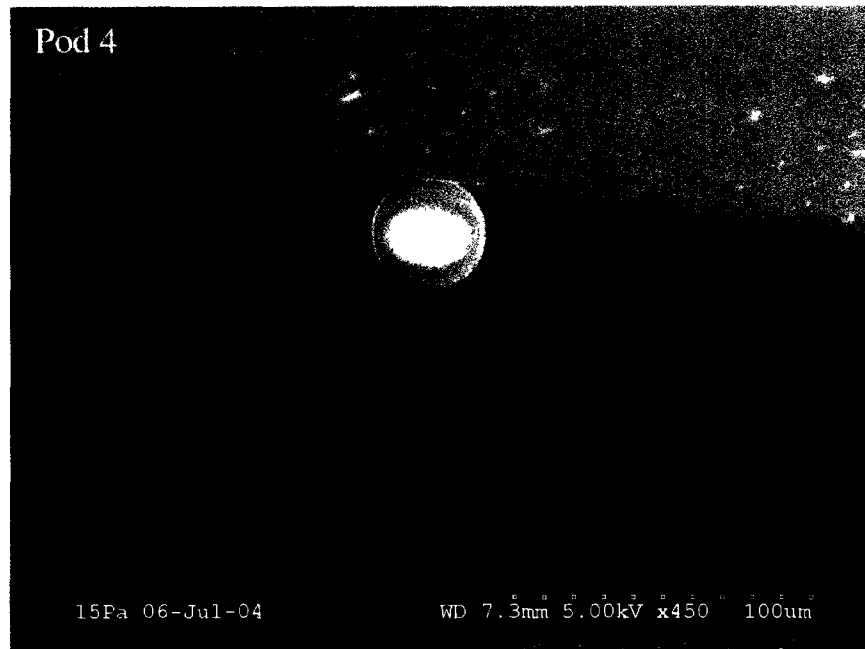
Figure 39. Image collected from Hitachi S3500N variable pressure scanning electron microscope of the **reprocessed Octopus 3[®] MT-104-8**. The image shows spherical shaped particle on the surface of the pod. Numerous 40-60 micron diameter particles were observed on this and other devices. Scale bar in each image.

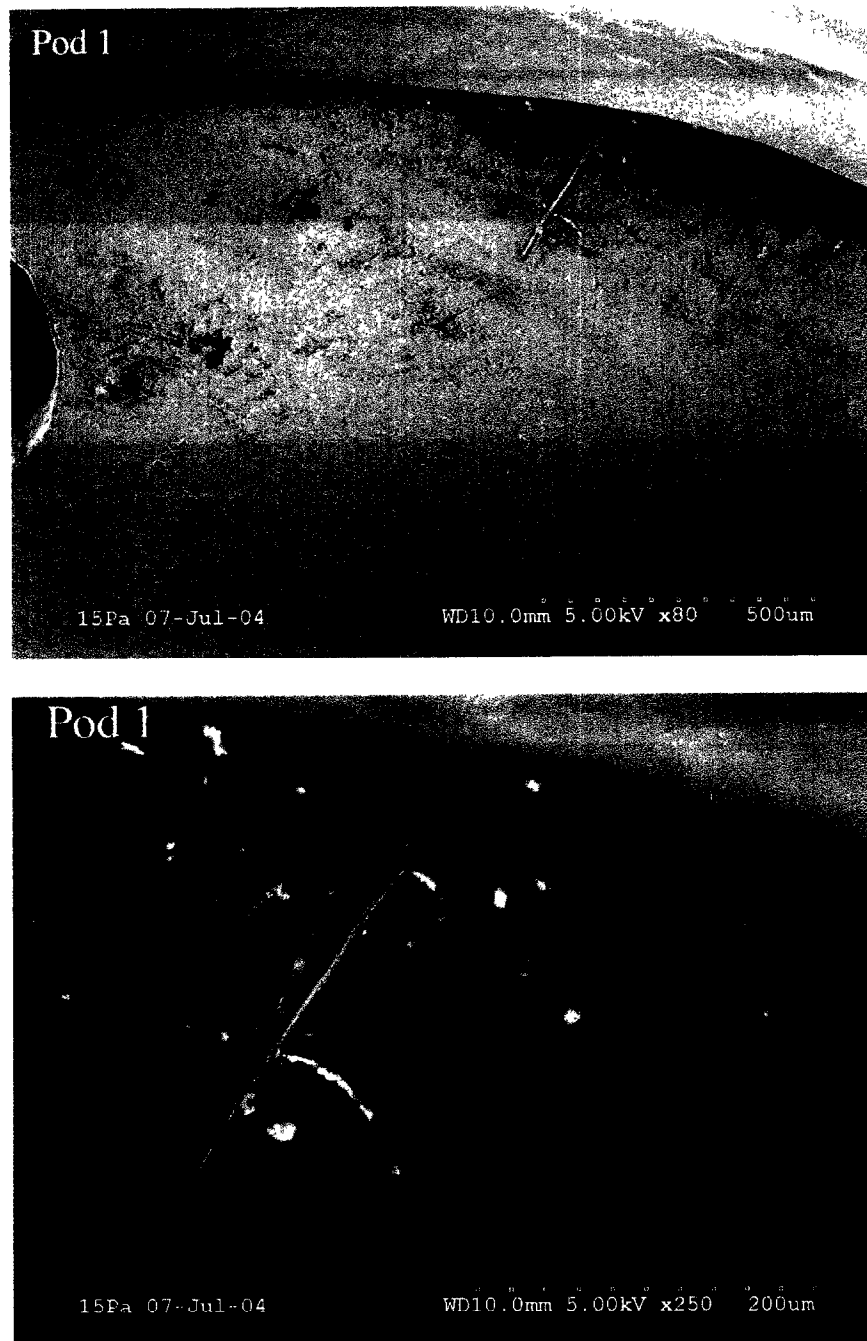
Figure 49. Images collected from Hitachi S3500N variable pressure scanning electron microscope of pod 1 on the **reprocessed Octopus 4[®] MT-104-10**. The images show various irregularities and contamination on the surface structure of the tubing and the pods. Bioburden debris and contamination is present on the surface of the tubing when compared to “new”. Note fiber. Scale bar in each image.

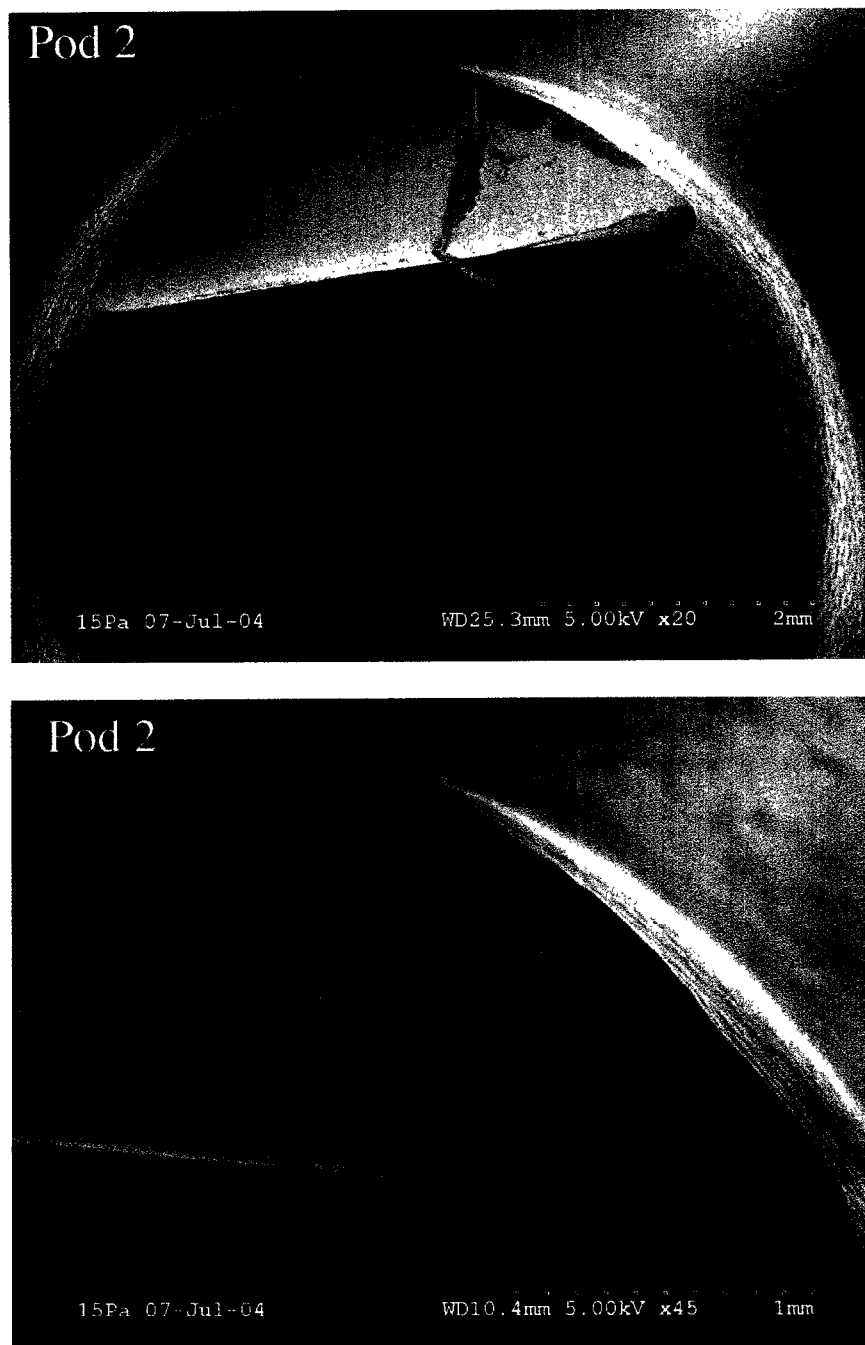
Figure 50. Images collected from Hitachi S3500N variable pressure scanning electron microscope of pod 2 on the **reprocessed Octopus 4[®] MT-104-10**. The images show various irregularities and contamination on the surface structure of the tubing and the pods. Bioburden debris and contamination is present on the surface of the tubing when compared to “new”. Note large fragment of material. Scale bar in each image.

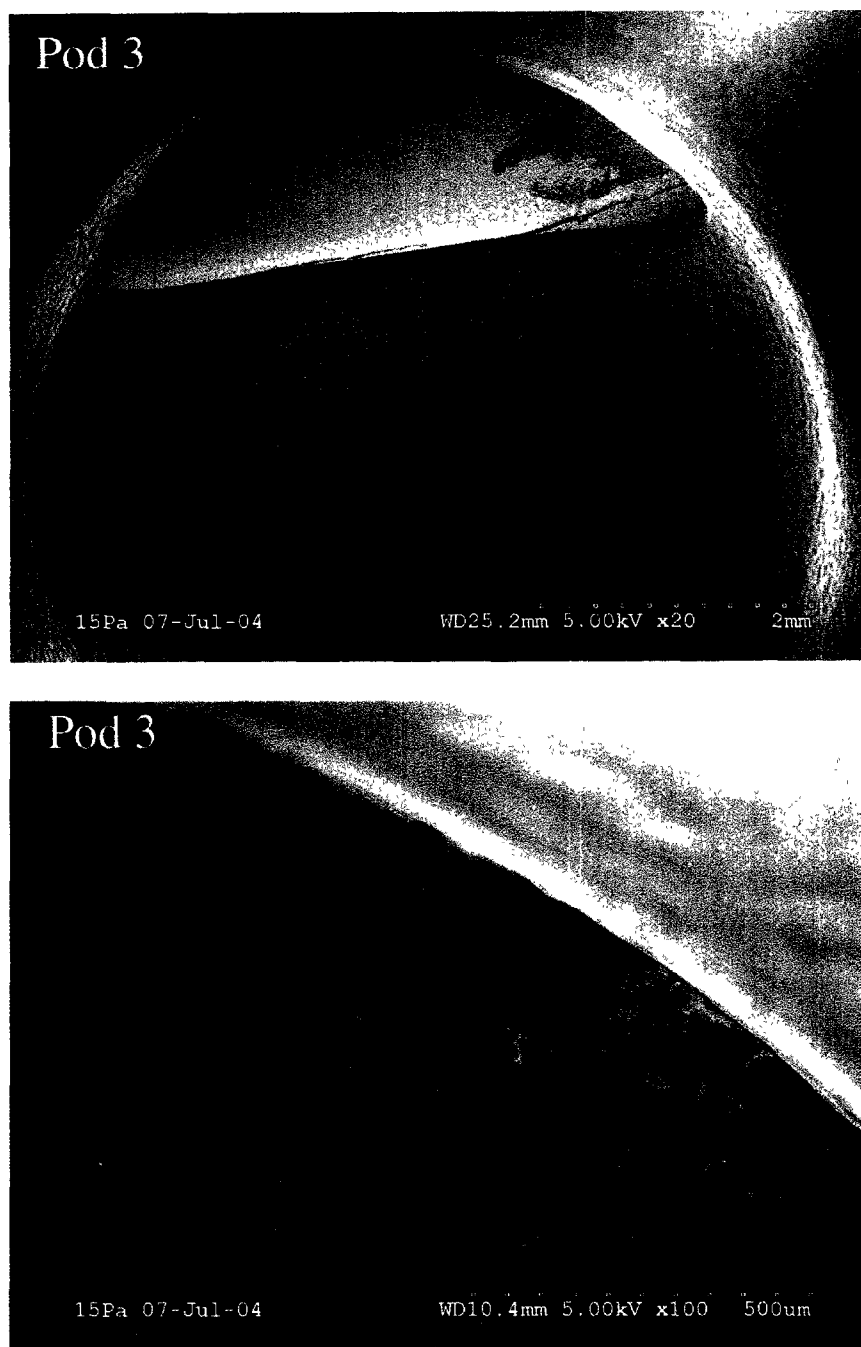
Figure 51. Images collected from Hitachi S3500N variable pressure scanning electron microscope of pod 3 on the **reprocessed Octopus 4[®] MT-104-10**. The images show various irregularities and contamination on the surface structure of the tubing and the pods. Bioburden debris and contamination is present on the surface of the tubing when compared to “new”. Note “sheet” of foreign material on tubing surface. Scale bar in each image.

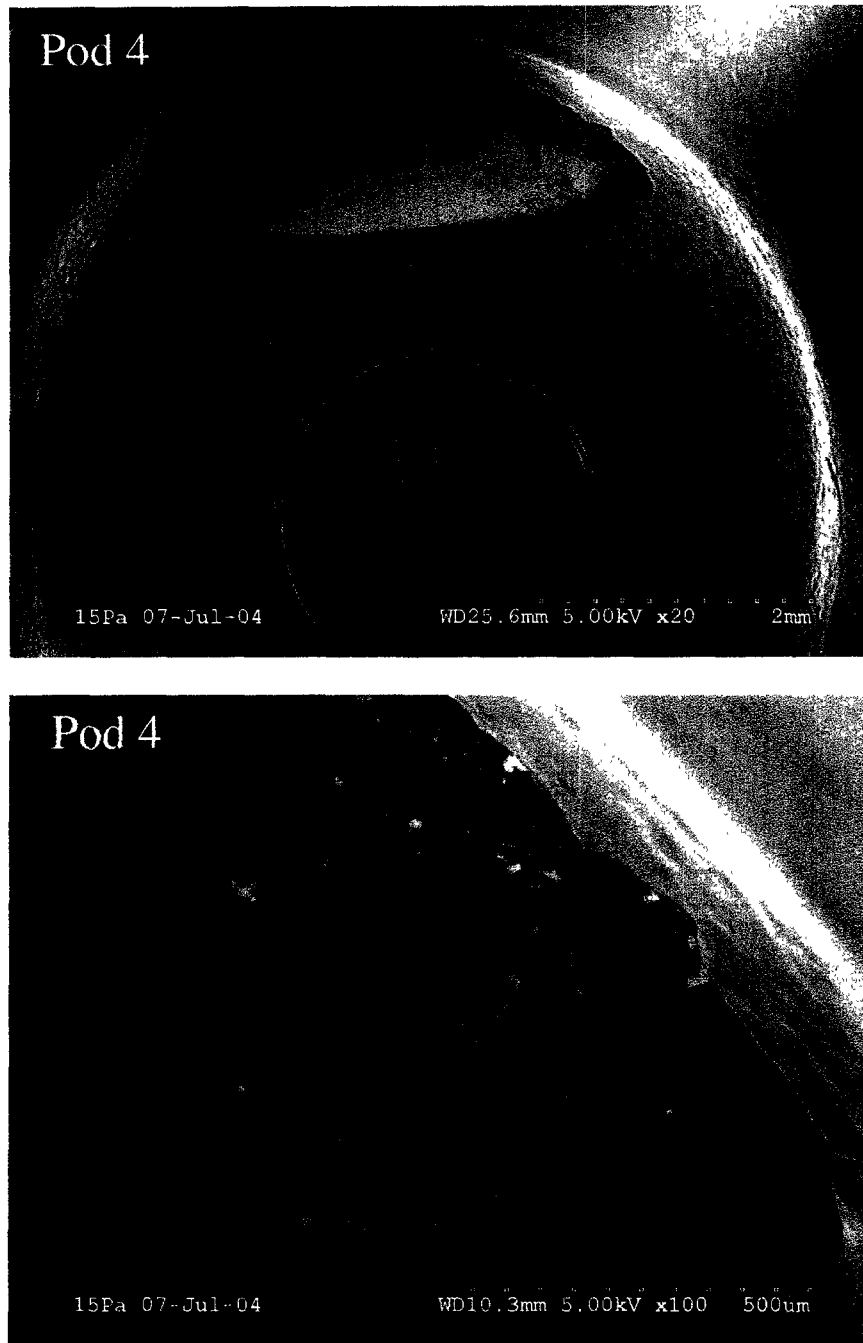
Figure 52. Images collected from Hitachi S3500N variable pressure scanning electron microscope of pod 4 on the **reprocessed Octopus 4® MT-104-10**. The images show various irregularities and contamination on the surface structure of the tubing and the pods. Bioburden debris and contamination is present on the surface of the tubing when compared to “new”. Note sheet of material on tubing, gap between pod and hypotube and the partially blocked opening. Scale bar in each image.

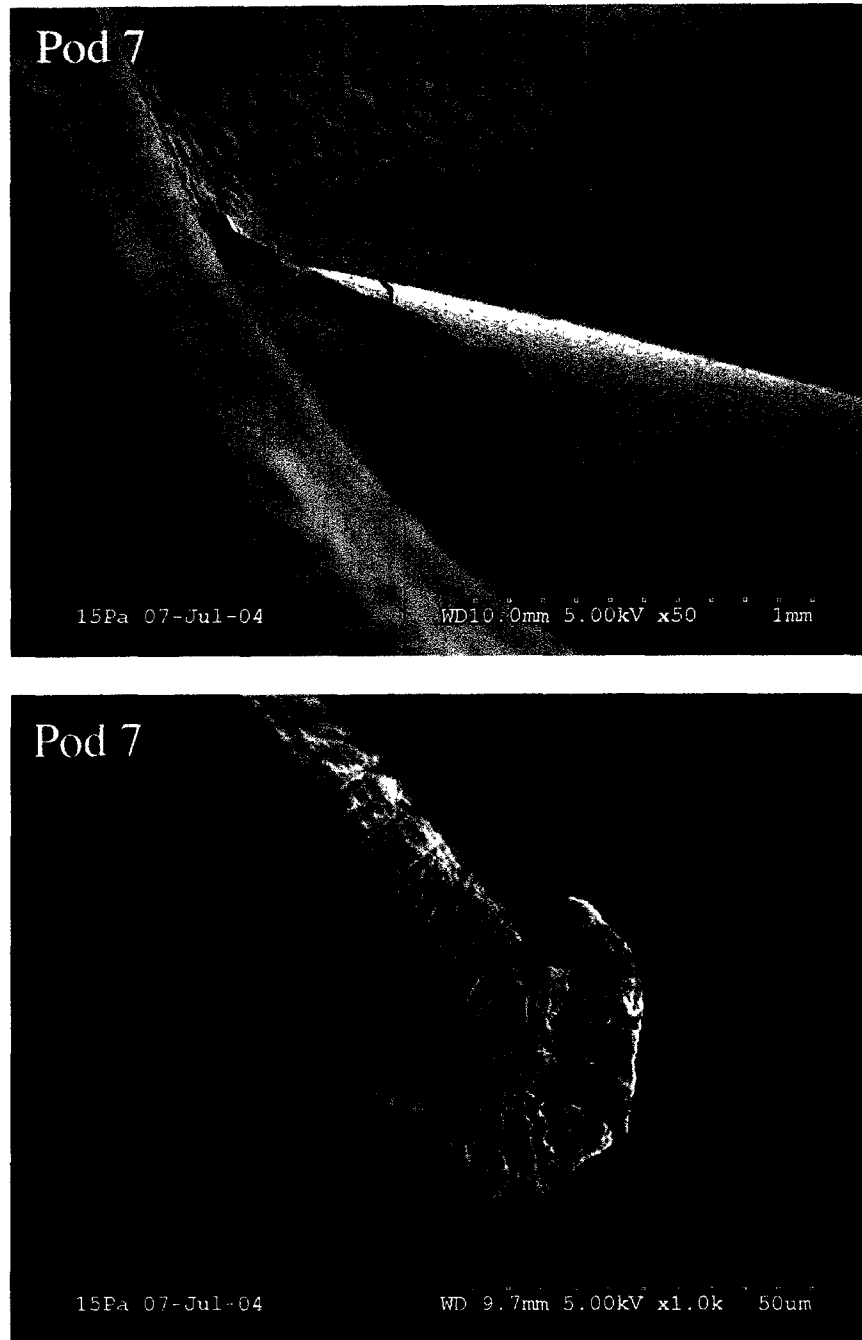
Figure 54. Images collected from Hitachi S3500N variable pressure scanning electron microscope of pod 7 on the **reprocessed Octopus 4[®] MT-104-10**. The images show various irregularities and contamination on the surface structure of the tubing and the pods. Note hair-like fiber in lower panel. Scale bar in each image.

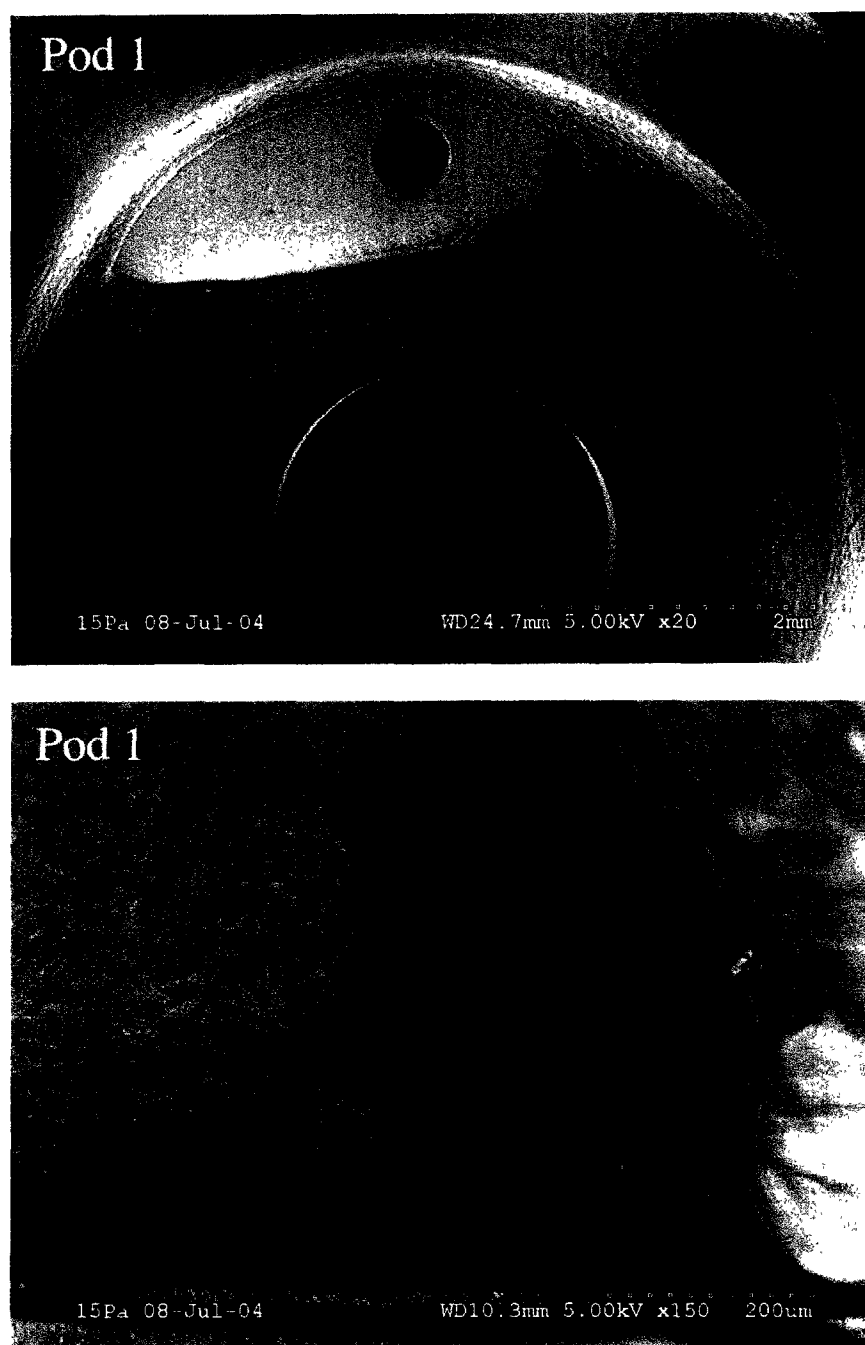
Figure 55. Images collected from Hitachi S3500N variable pressure scanning electron microscope of pod 1 on the **reprocessed Octopus 4[®] MT-104-11**. The images show various irregularities and contamination on the surface structure of the tubing and the pods. Bioburden debris and contamination is present on the surface of the tubing when compared to “new”. Note “sheet” of foreign material on tubing surface. Scale bar in each image.

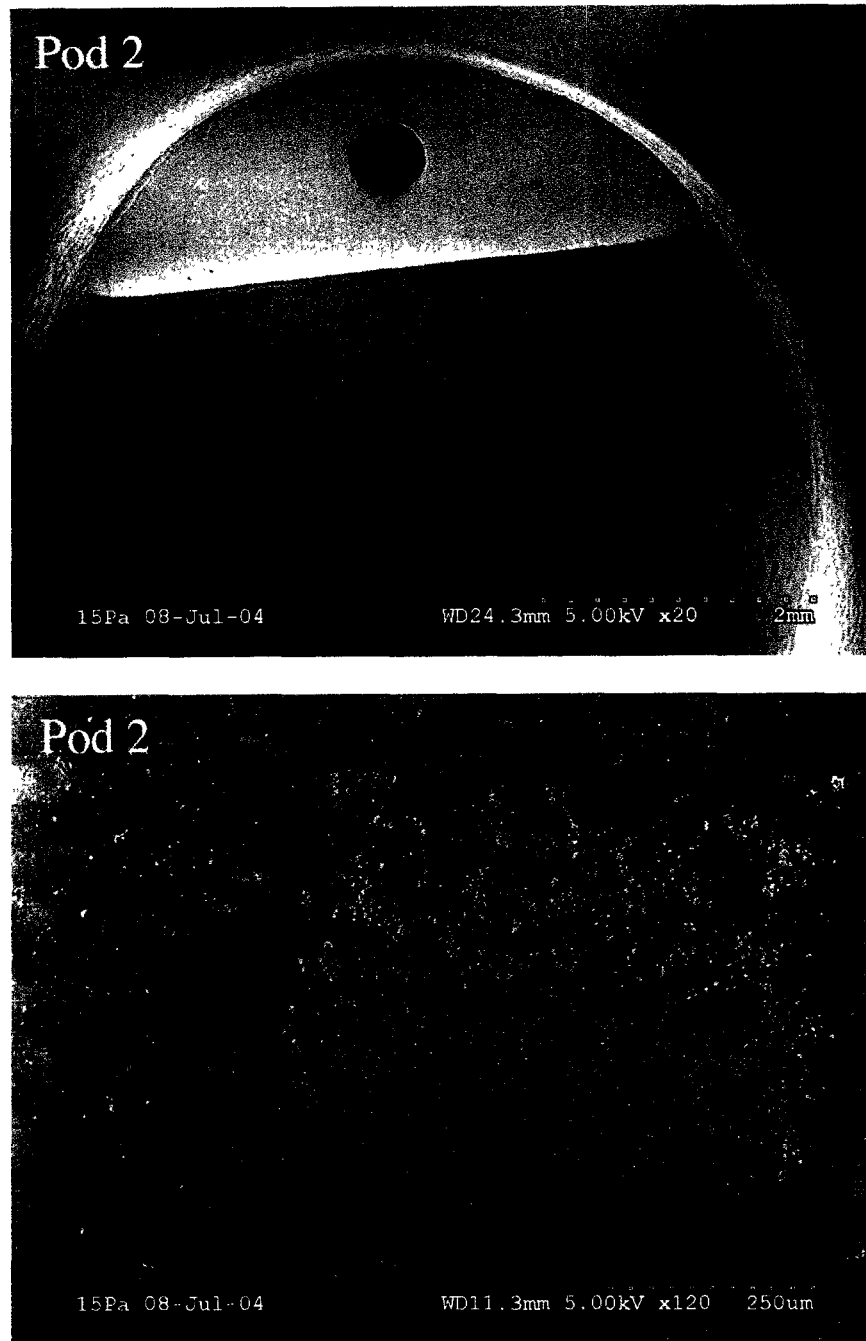
Figure 56. Images collected from Hitachi S3500N variable pressure scanning electron microscope of pod 2 on the **reprocessed Octopus 4[®] MT-104-11**. The images show various irregularities and contamination on the surface structure of the tubing and the pod. Bioburden debris and contamination is present on the surface of the pod when compared to “new”. Scale bar in each image.

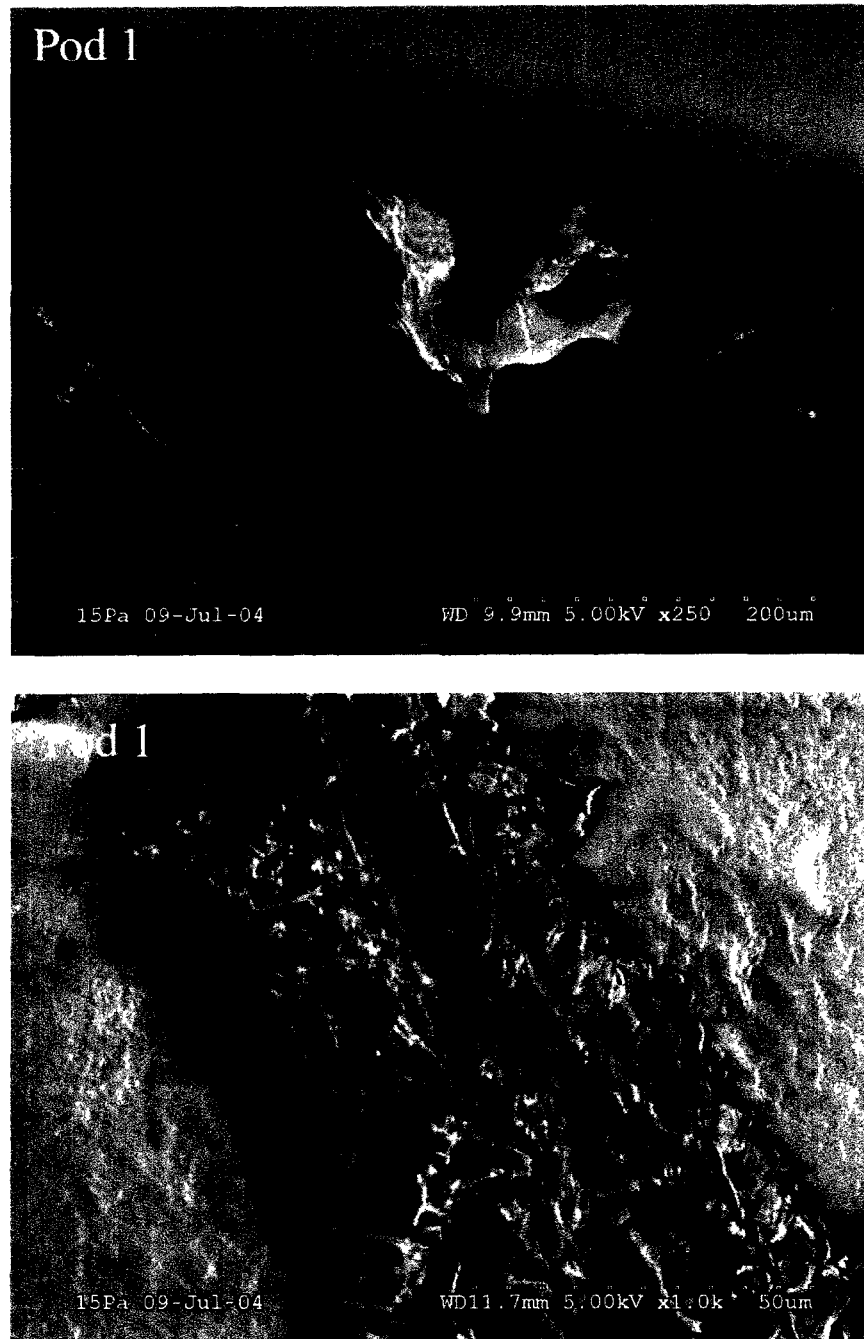
Figure 60. Higher magnification views of debris in pod 1 on the **reprocessed Octopus 4[®] MT-104-13**. The number in the upper left indicates the pod # (see Figure 5). Scale bar in each image.

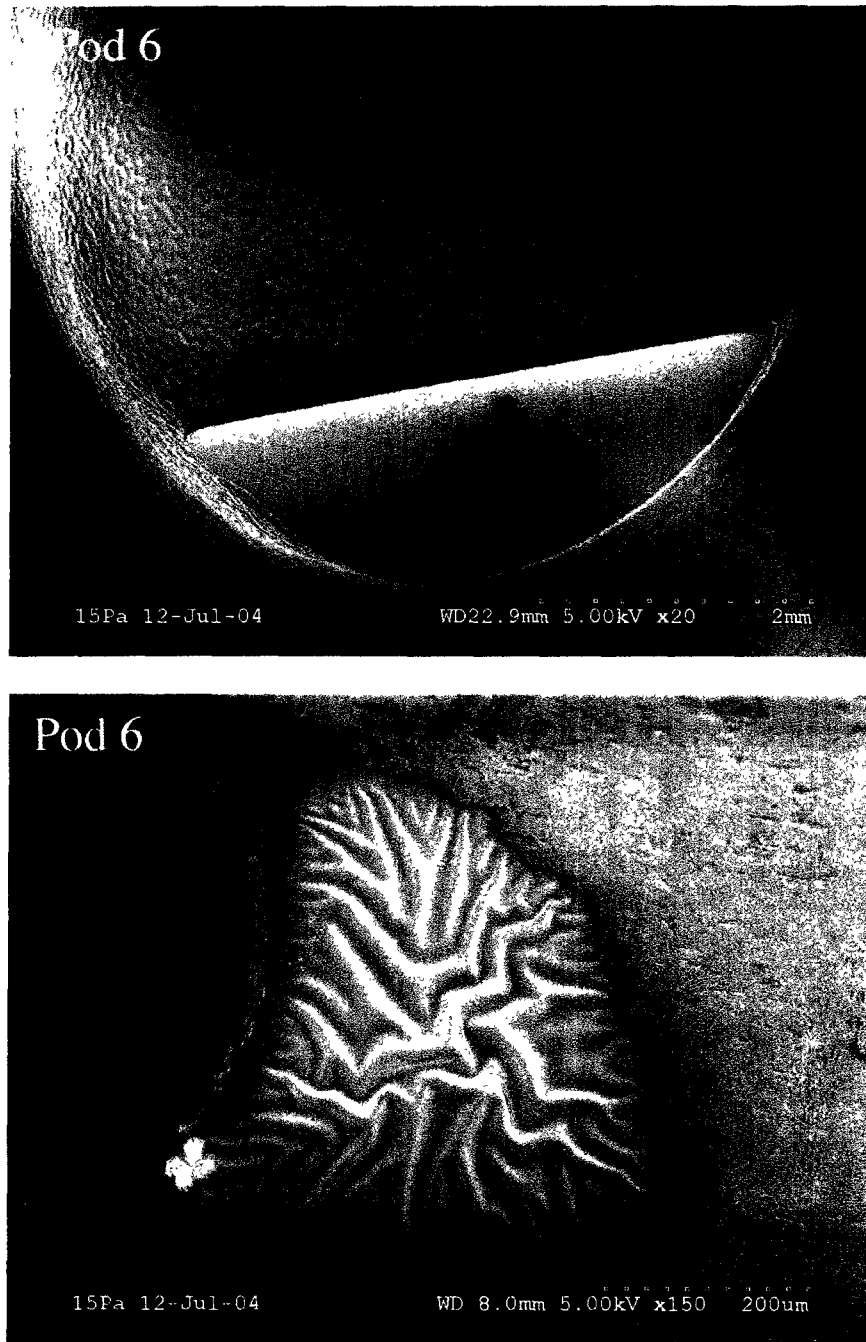
Figure 72. Images collected from Hitachi S3500N variable pressure scanning electron microscope in the areas of pod 6 on the **reprocessed Octopus 4[®] MT-104-16**. Note contamination and dried liquid material near hypotube opening. The number in the upper left indicates the pod # (see Figure 5). Scale bar in each image.

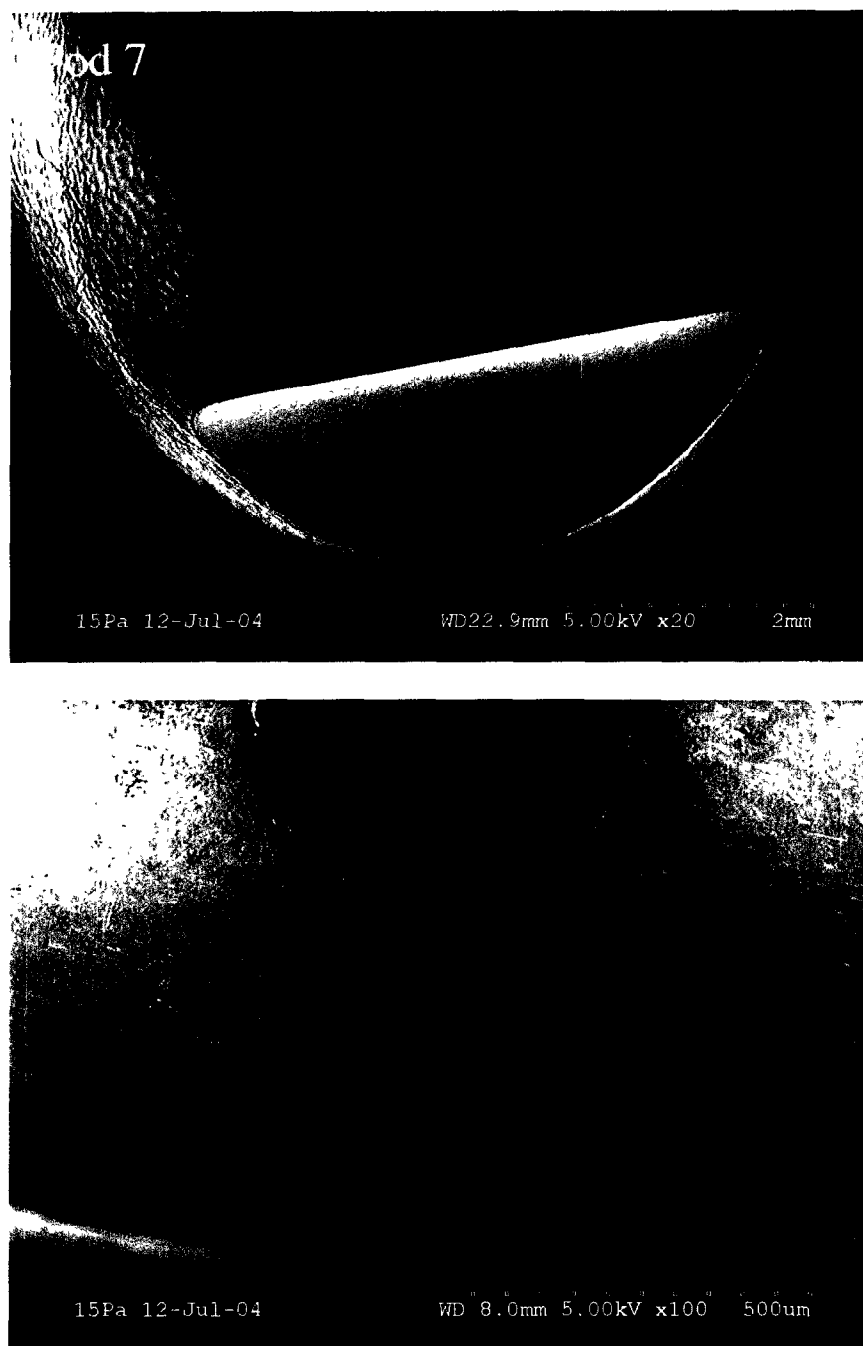
Figure 73. Images collected from Hitachi S3500N variable pressure scanning electron microscope in the areas of pod 7 on the **reprocessed Octopus 4[®] MT-104-16**. Note contamination and dried liquid material near hypotube opening. The number in the upper left indicates the pod # (see Figure 5). Scale bar in each image.
